Wound debridement with the VERSAJET Hydrosurgery system: a novel technique available at Strömsholm Equine Hospital

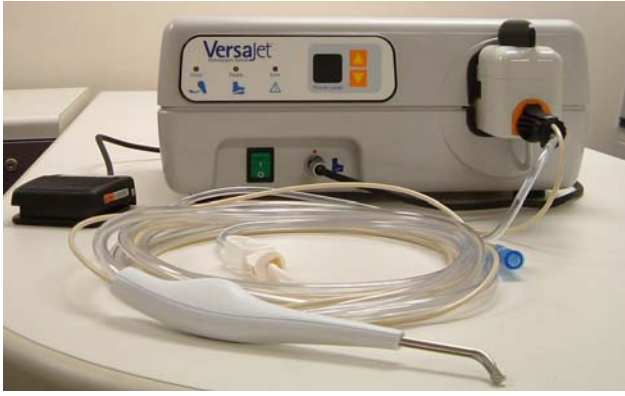
Figure 1: Versajet console and handpiece

The VERSAJET (VJT) Hydrosurgery system has been developed for both acute and chronic wound debridement. It consists of a power console and reusable handpiece (Figure 1). The console is foot pedal activated and utilises sterile fluid bags for irrigant and a standard waste receptacle for effluent. The system utilises a high velocity stream of sterile saline, which jets across the operating window of the handpiece. This creates a localised vacuum (*venturi effect*) enabling the surgeon to hold, cut, and remove damaged tissue and contaminants, whilst simultaneously irrigating the wound (Figure 2). Moreover, the VJT provides immediate fluid evacuation, and so there is minimal saturation of the operative field. Handpiece orientation relative to the tissue determines the effect. In addition to altering orientation, depth and speed of debridement can be adjusted using the variable power settings.

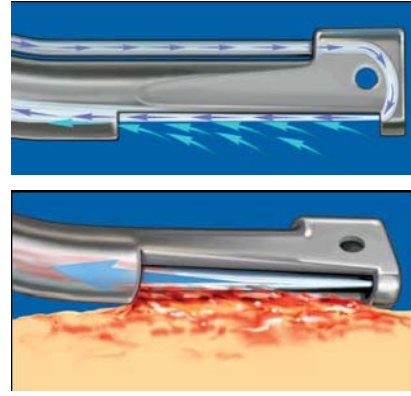
Figure 2: Venturi effect created by the handpiece

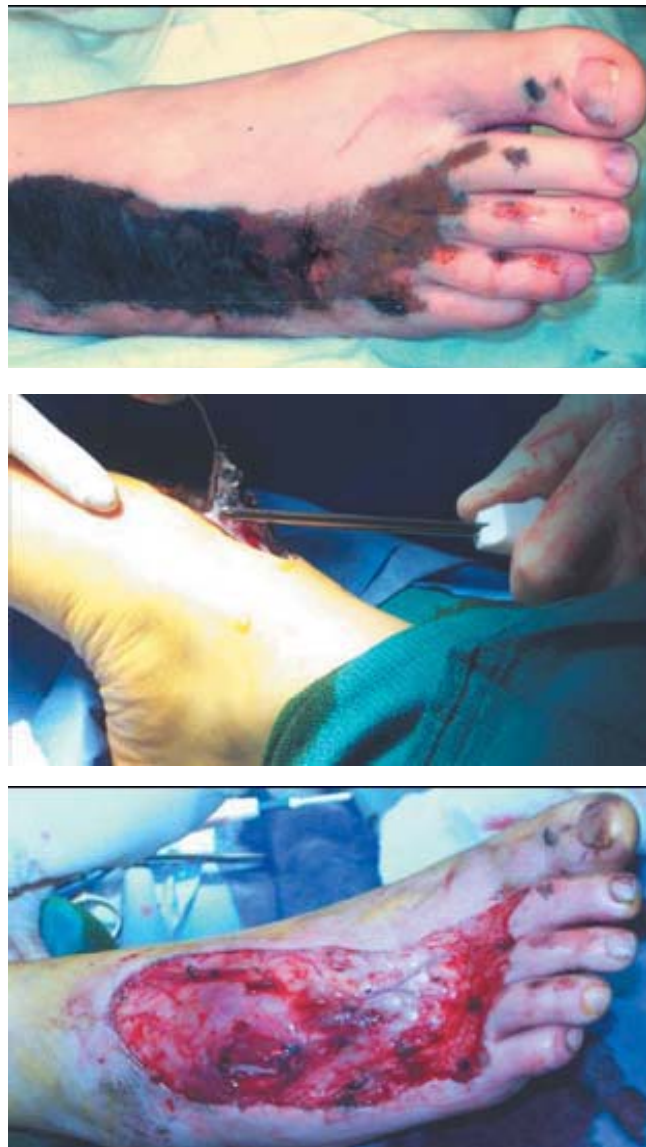
Figure 3: Versajet being used for the debridement of severe burn wounds in the foot

In human medicine, the system has been used successfully in the debridement of damaged and necrotic tissue in traumatic wounds, chronic wounds such as venous ulcers, and burns (Figure 3). In a pilot study, the use of the VJT was compared with sharp debridement and pulsatile lavage in patients with open soft tissue or fracture wounds. There was the suggestion that the VJT resulted in fewer debridement procedures and a faster time to closure. In a cadaver study, the VJT was significantly more effective at removing contaminants compared to high pressure pulsatile lavage.

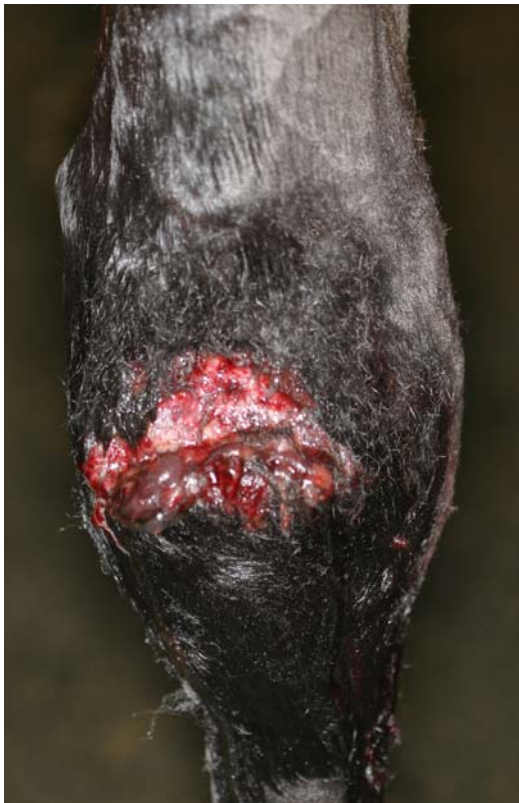
Figure 4: Severe trauma to left carpus following a fall at a water jump

A 7 year old mare presented to the hospital after falling in the water jump at a horse trials. There was severe trauma to the left carpus (Figure 4), although fortunately no communication with the carpal joints. At surgery, extensive abrasive damage to the extensor carpi radialis tendon was evident, ingrained with grit. The remainder of the wound was also grossly contaminated (Figure 5). At surgery, the wound and exposed tendon were carefully debrided with the aid of the VST system. The skin flap was tacked in place to prevent contraction and penrose drains inserted (Figure 6). The wound healed remarkably well and within three weeks only a small defect at the proximal extent remained (Figure 7). There was no need for further debridement or skin grafting.

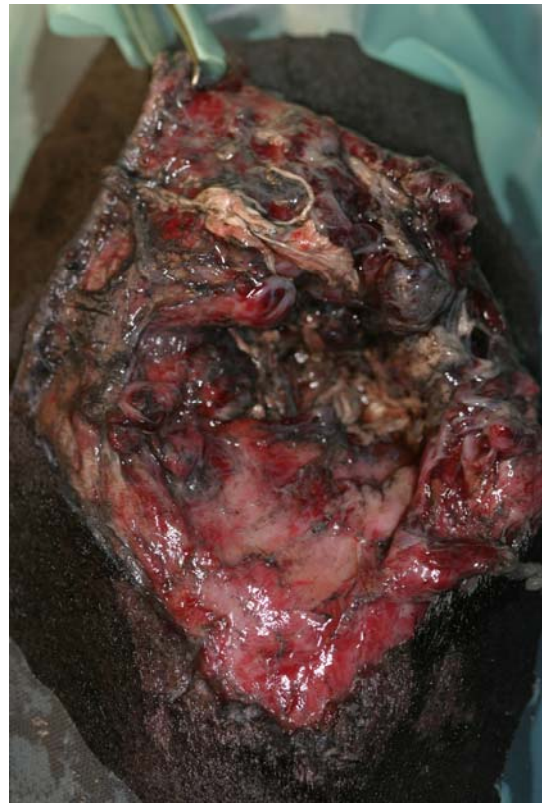
Figure 5: At surgery, the full extent of the contamination and abrasive damage to the extensor carpus radialis tendon became evident

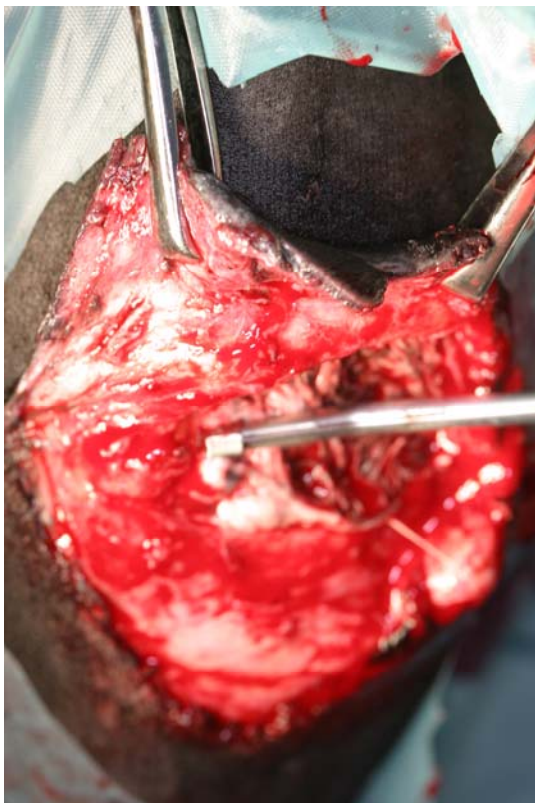
Figure 6: The wound and exposed tendon are carefully debrided with the Versajet system

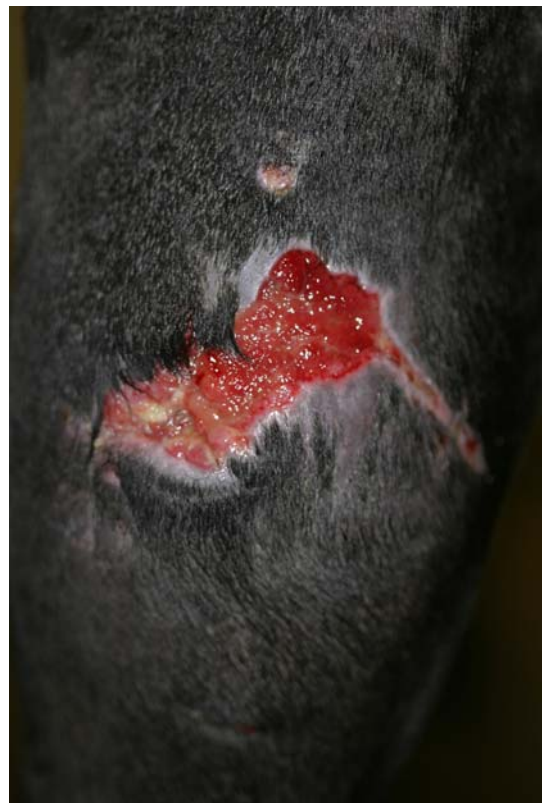
Figure 7: Three weeks following injury, only a small defect remains.
